Re: Rio Algom Mining LLC/Ambrosia Lake Mine; Major; Individual Permit; SIC 1094; NPDES Compliance Evaluation Inspection; NM0020532; June 4, 2014

NPDES Compliance Inspection Report

Rio Algom Mining Company, LLC; Ambrosia Lake Mine
NPDES Permit No. NM0020532
Compliance Evaluation Inspection
June 4, 2014

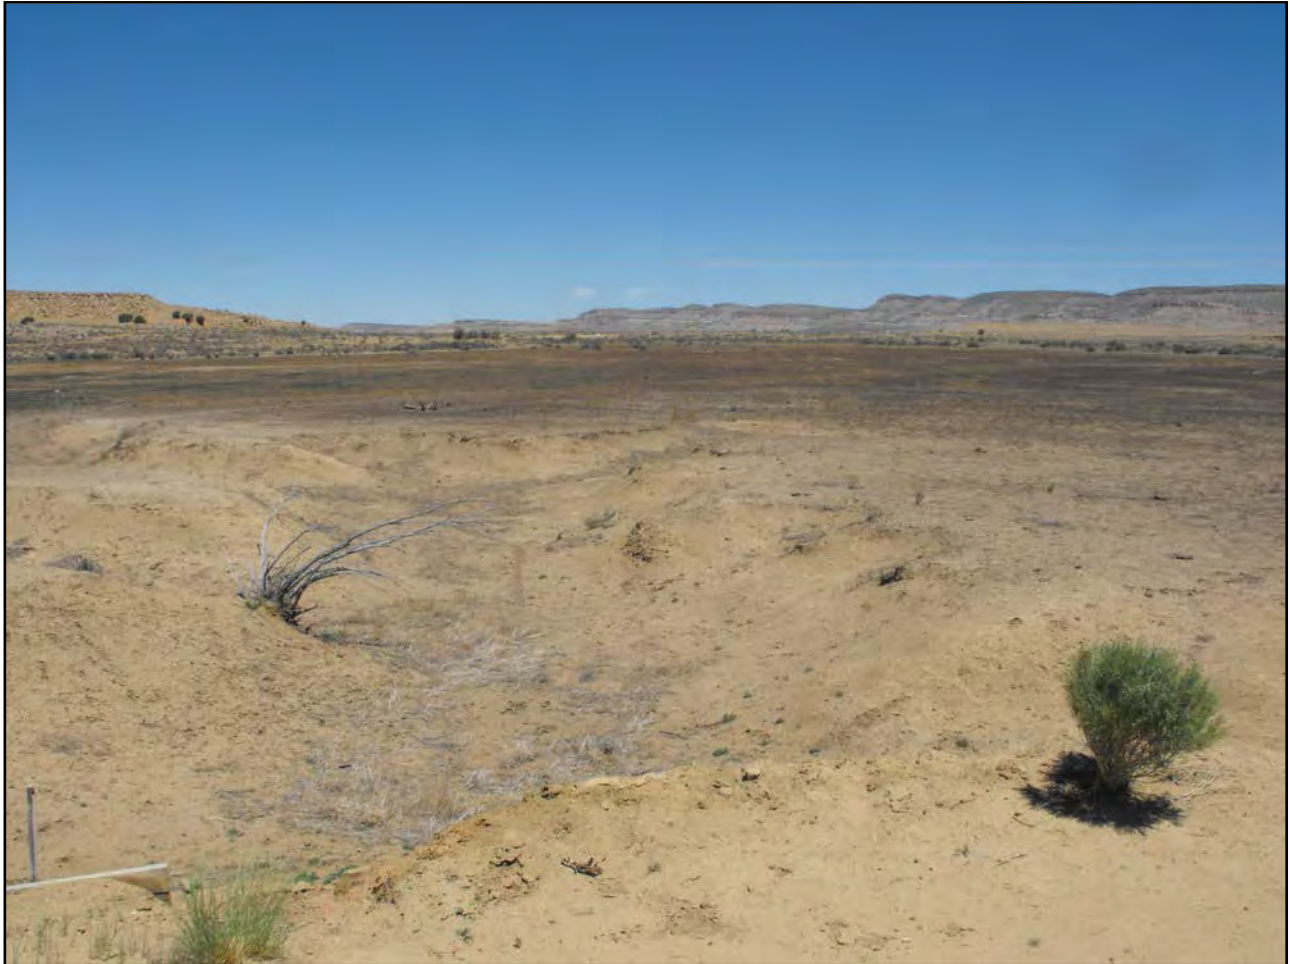
Photo #1:

Please refer to the map in Appendix A of this report. The outfall for this facility is located approximately one mile downstream of any mine runoff locations. The outfall location does not appear to be representative of the activity at this facility and, additionally, is located within the receiving waterbody.

Photographer:	Daniel Valenta	Date	6-4-2014	Time	1208 hours
Location:	Rio Algom/Ambrosia Lake Mine				
Subject:	View upstream of the flow recording equipment at Outfall 001. The outfall is located in Section 5, an area of BHP Billiton's holdings that was never intended to be mined. The outfall is located approximately one mile downstream of the drainage.

Currently RAML does not discharge mine drainage water from the facility. In addition, there have been no stormwater discharges from the outfall in several years. We are in the process of preparing the documentation needed to submit a Notice of Intent (NOI) to comply with the Multi-Sector General Permit (MSGP) for stormwater discharges from industrial facilities. We expect to submit a NOI shortly after the Environmental Protection Agency adopts a new MSGP. Once we have been granted coverage under the MSGP, we intend to file for termination of Permit No. NM0020532. We believe that this approach will address concerns regarding the outfall location.

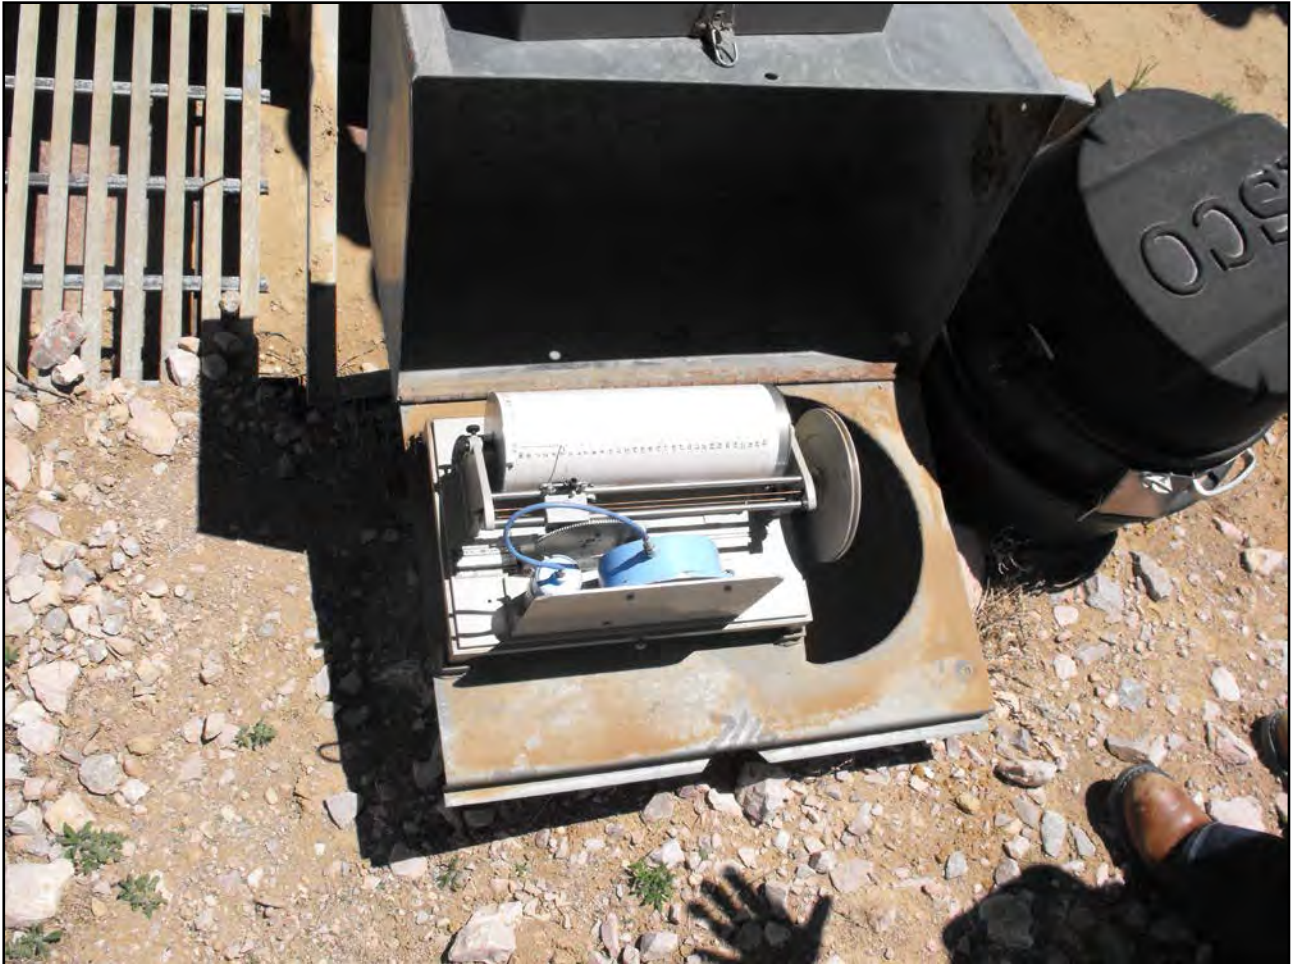
Photo #2:

During the prior facility inspection, conducted by USEPA on March 21, 2012, the EPA inspector noted that the onsite battery powered Stevens Recorder (a float/mechanical flow meter with a paper strip to record flow data) had not been calibrated. The inspector noted that at the time there had not been any measurable flow in the past year, however, the suggestion was made at that time that the meter should be calibrated using a simulated flow.

This finding is unchanged at the time of this inspection. The same flow monitoring equipment was present at the facility site, but there was no effort made since the previous inspection to calibrate the flow meter to ensure an accurate flow.

Photographer:	Daniel Valenta	Date	6-4-2014	Time	1210 hours
Location:	Rio Algom/Ambrosia Lake Mine				
Subject:	Stevens Recorder for flow measurement at Outfall 001. This equipment had not been calibrated.

Finally, our field team performed maintenance and initial calibration of the flow measurement equipment at the outfall on July 2, 2014. We have scheduled additional work and further calibration of the Parshall flume and Stevens Recorder to occur in the next several weeks.

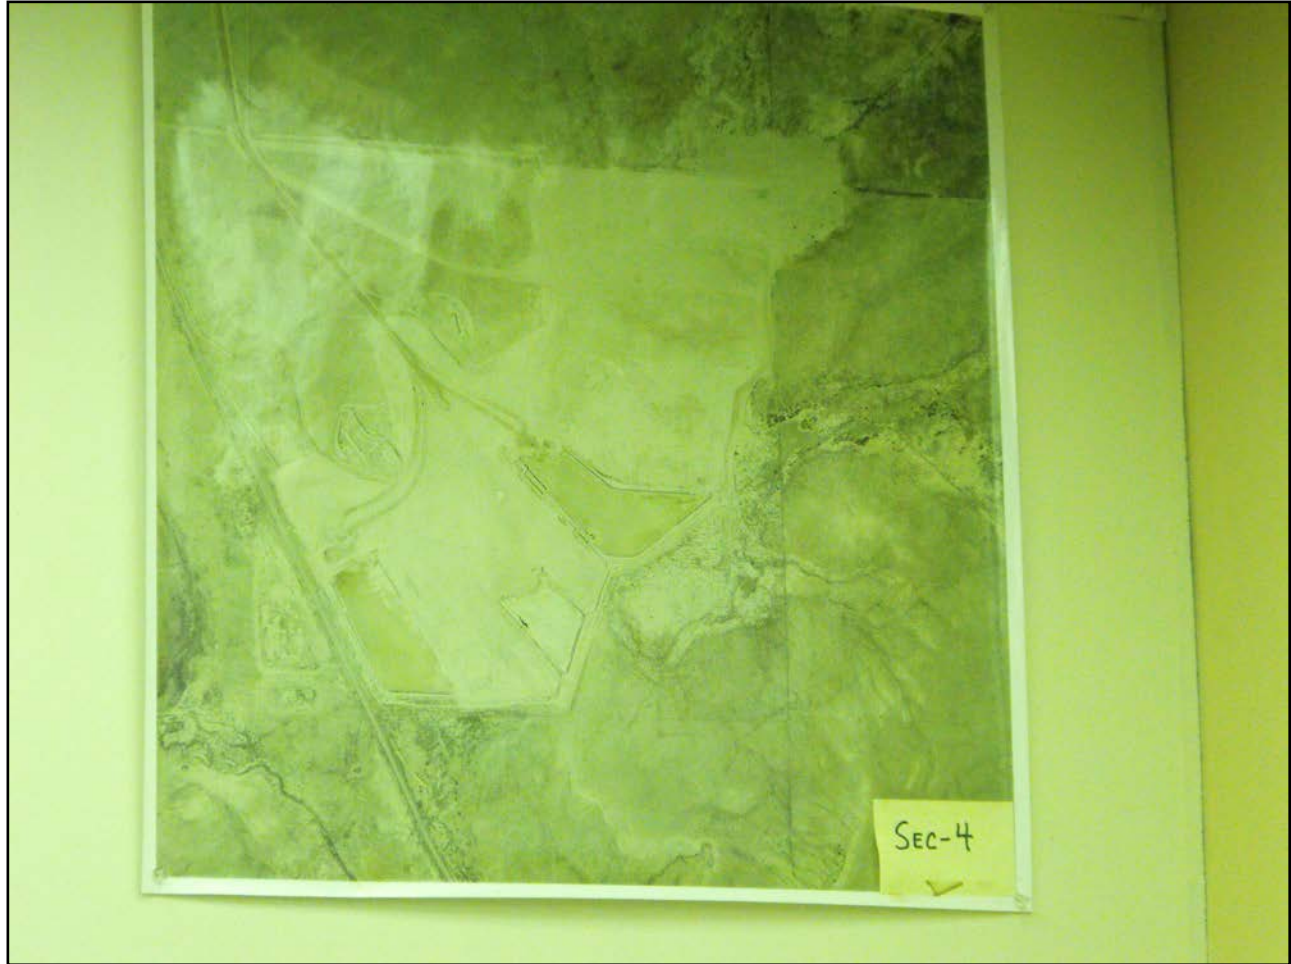
Photo #3:

Additionally, there are a number of old tailings ponds in Section 4, on the eastern side of NM-509 that do not appear to be covered under this permit. The ponds have not been fully remediated, as the permittee's representative indicated that soil remediation in that area would take place during this next phase of the remediation project. The inspectors looked for culverts or other signs of hydrological connection under NM-509 that would lead to Outfall 001, but were unable to locate any evidence that stormwater runoff from the Section 4 ponds would connect to the outfall. The permittee's representative indicated that the site was bermed, however, there was no information what size storm the berms were designed to accommodate. A discharge, if one occurred, from the Section 4 pond area does not appear to be authorized under this permit and would need designation as a separate outfall.

Photographer:	Daniel Valenta	Date	6-4-2014	Time	1244 hours
Location:	Rio Algom/Ambrosia Lake Mine				
Subject:	Map of old Section 4 tailings ponds on the east side of Highway 509.

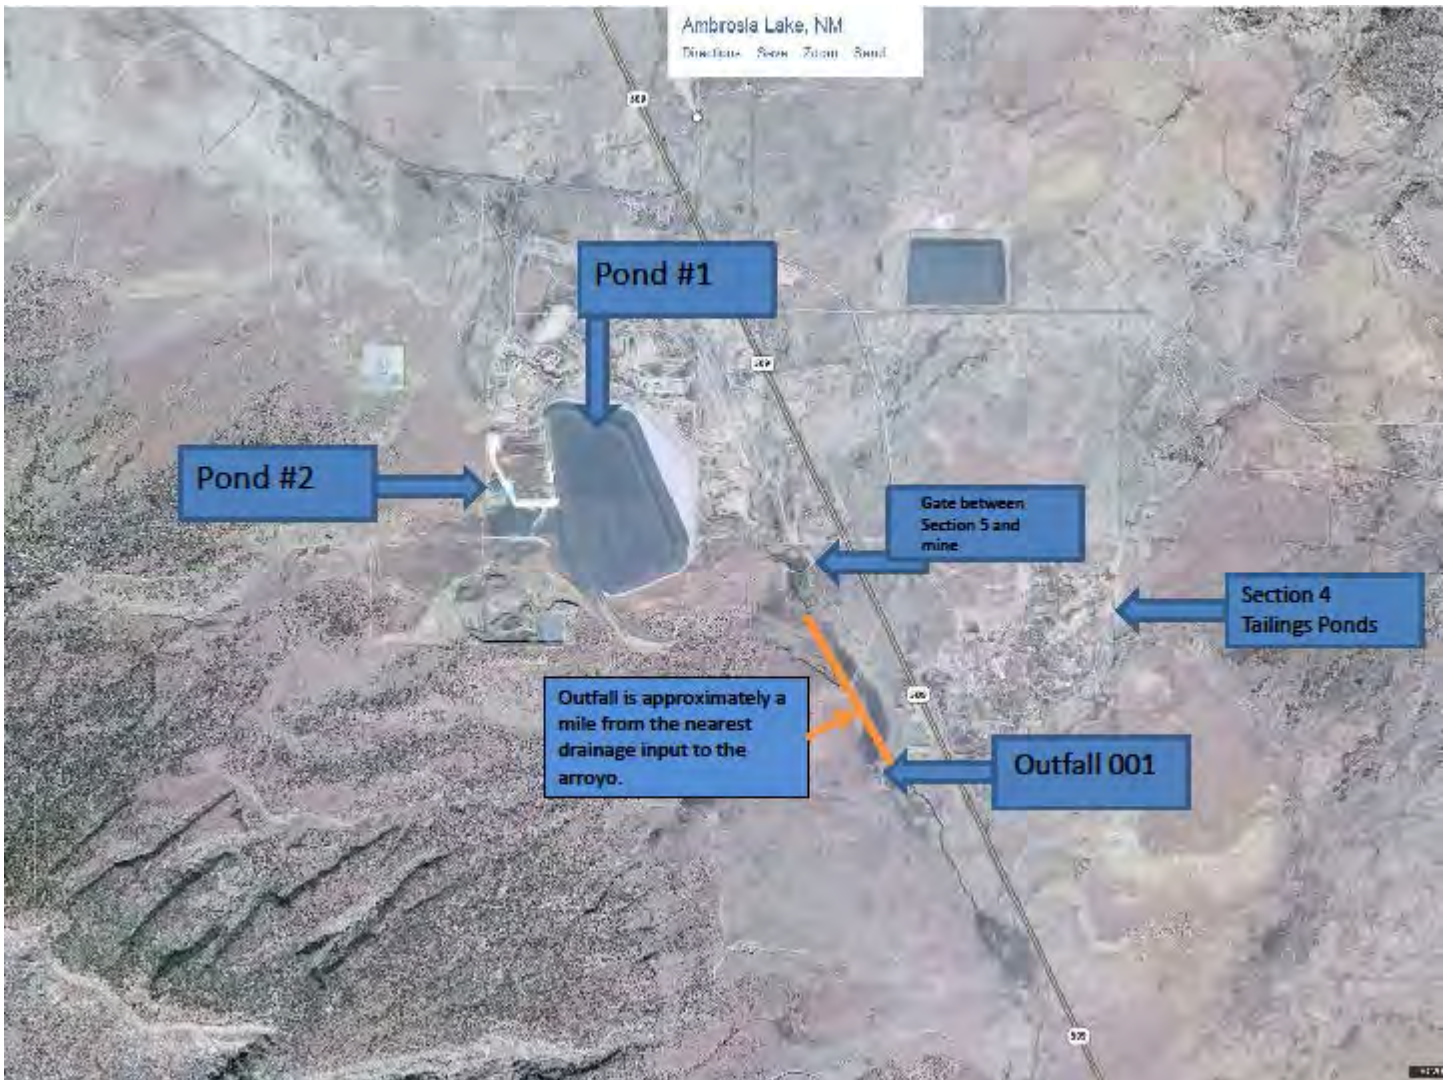
The mill equipment was demolished in 2003 and disposed in Pond #1. (Please see map attached as Appendix A to this report.) The structures that currently remain on site are the machine shop, water treatment facility, ion exchange building and the site offices.
